Debris/Ice/TPS Assessment and Integrated Photographic Analysis of Shuttle Mission STS-111

Author Name: Armando Oliu

June 2005

June 5, 2002

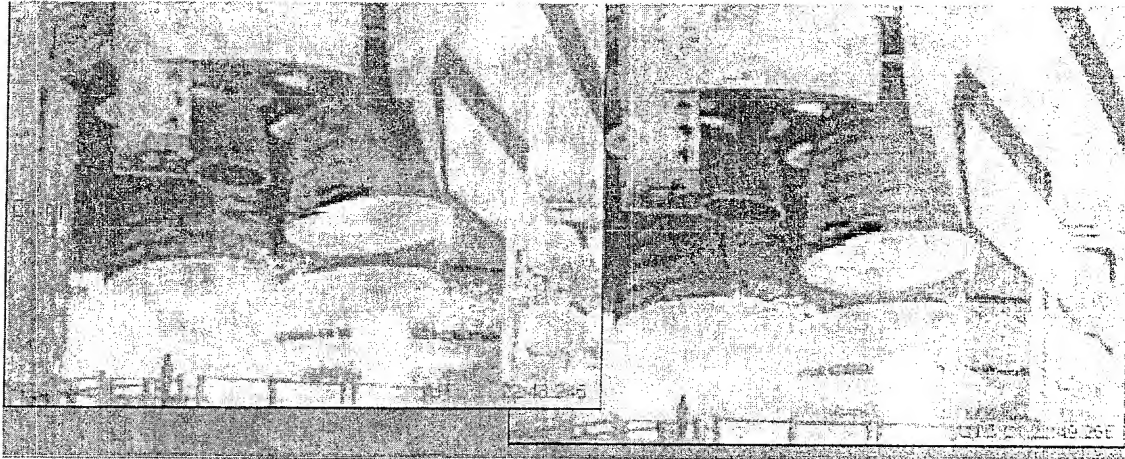
Figure 2.1 (B) Light Colored Area on Inside of SSME #1 (Camera E77)

A light colored area was seen on the inside of SSME #1 that may have been an indication of a hot wall leak. However, KSC reported that the view was showing a small area of turbulence inside the SSME #1 engine that was caused by weld beads.

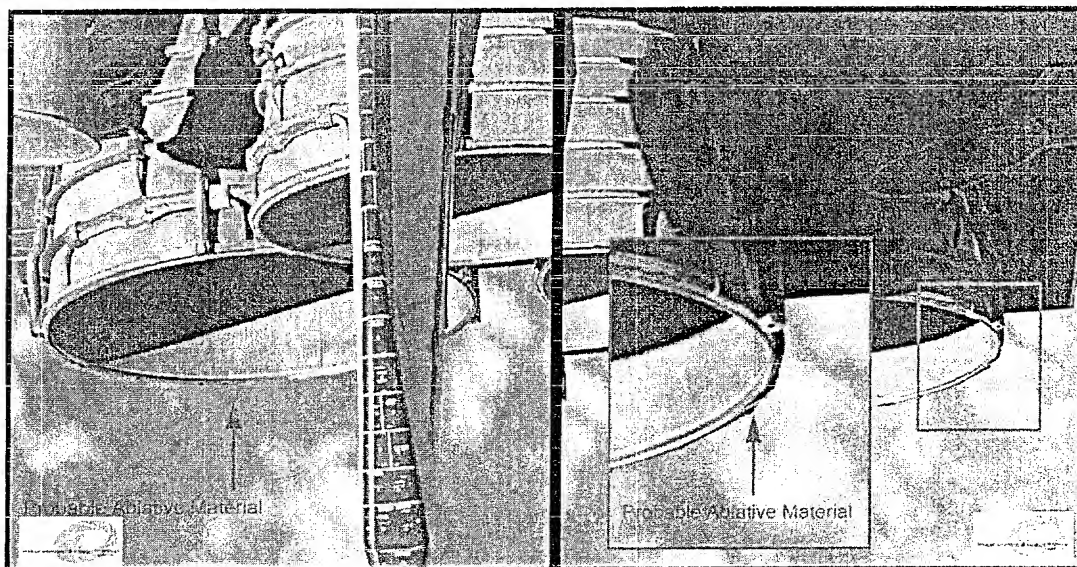
CFVR-111-03: Ablative Material Protruding from -Z Rim of SSME #2 and from the +Y Rim of SSME #3

Figure 2.1 (D) Ablative Material on SSME Rims Seen On-Orbit (ISS004E13276)

Thin, red colored objects (ablative material) were seen protruding from the edge of the -Z rim of SSME #2 and from the +Y edge of SSME #3 on the downlinked digital imagery prior to landing.

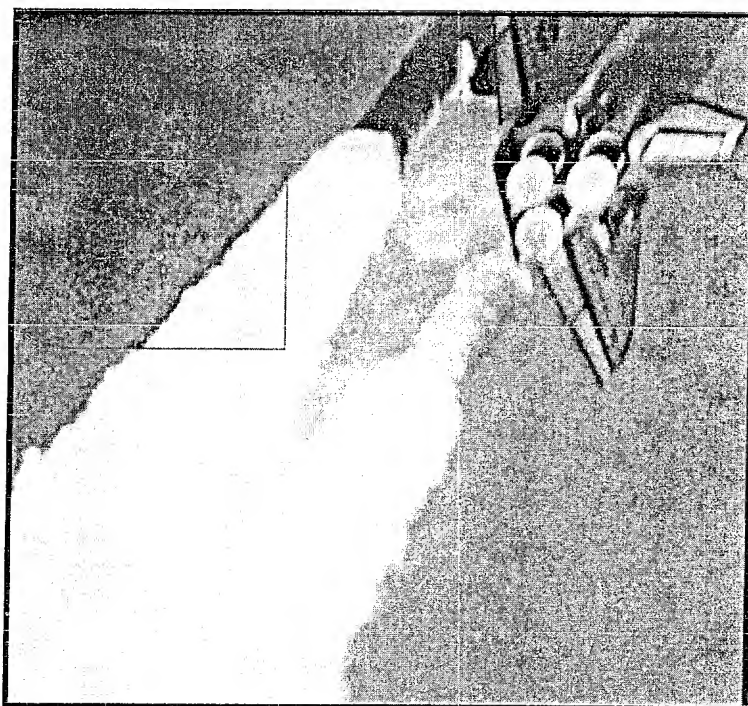
Figure 2.2.2 (A) Spray of Debris Exiting the LSRB Exhaust Plume (Camera E52)

Numerous pieces of debris (in excess of twenty) were seen falling aft from the LSRB exhaust plume near the LSRB aft skirt during early ascent (21:23:06.439 UTC). See Figure 2.2.2 (A). The debris occurred simultaneously on both sides of the LSRB exhaust plume. Approximately two seconds later, a second spray of debris (at least fifteen in number) was again seen in the same location on both sides of the LSRB exhaust plume

(21:23:08.287 UTC). Although debris exiting the SRB exhaust plumes has been typically seen on previous mission imagery, this event is considered unusual because of the amount (not size) of debris that was visible. (Camera E52)

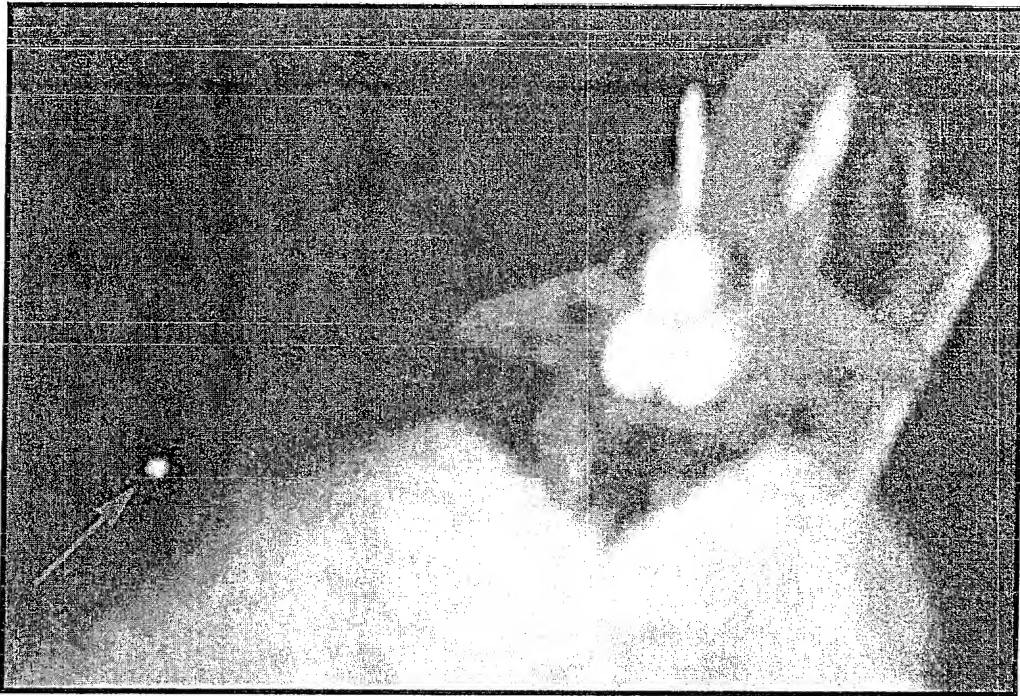
**Figure 2.2.2 (B) Debris Seen Exiting the SRB Exhaust Plume During Ascent
(Camera E207)**

Other debris was also seen exiting the SRB exhaust plumes late during ascent. The debris exiting the SRB exhaust plumes during late ascent was probably instafoam from the aft end of the SRB's. See Figure 2.2.2 (B). The more dense appearing debris near the time of tail-off, just prior to SRB separation, was probably SRB slag debris. Examples of this debris are provided in Table 2.2.2 (B).

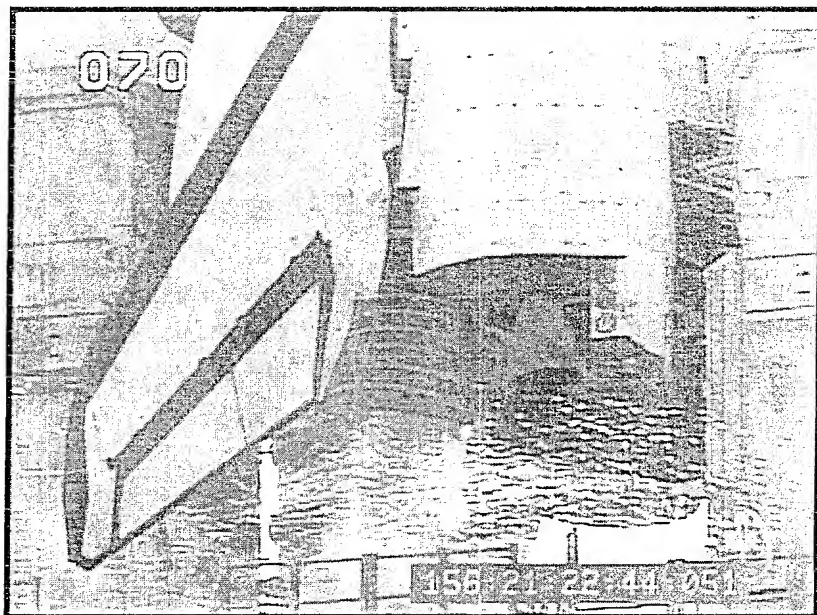
**Figure 2.2.3 (A) Orange Vapor Seen Forward of SSME Rims Prior to Liftoff
(Camera OTV070)**

Orange vapor (possibly free burning hydrogen) was seen forward of the SSME rims, near the base heat shield, near the trailing edge of the vertical stabilizer, near the drag chute door, and on the $-Z$ side of the body flap, during SSME ignition (21:22:44.021 UTC). See Figure 2.2.3 (A). With the exception of the orange-colored flash described under section 2.1, the orange vapor on the STS-111 films appeared to be similar to those typically seen on previous mission films and videos. (Cameras E2, E18, E20, E76, OTV063, OTV070)

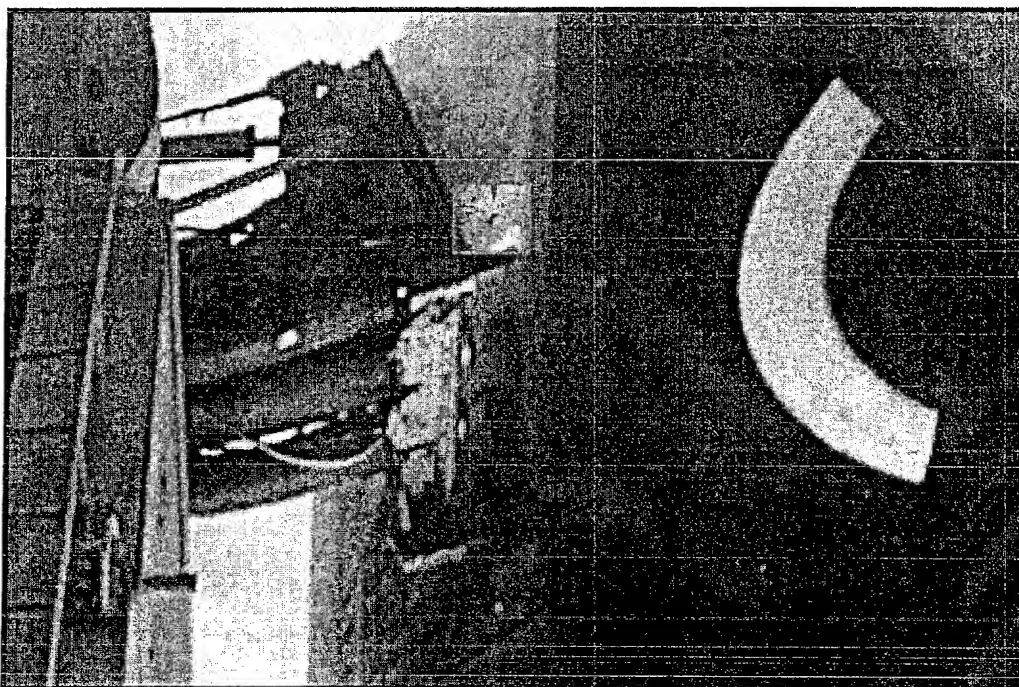
**Figure 2.2.3 (B) Ground Strap Seen During LO2 TSM T-0 Umbilical Retraction
(Camera E17)**

A small, dark-colored, object was seen trailing the LO2 TSM T-0 umbilical during retraction (21:22:49.406 UTC). The object appeared to follow the T-0 umbilical toward the LO2 TSM before being lost from view. See Figure 2.2.3 (B). KSC reported that this object was the grounding strap that goes from the LO2 TSM to the Orbiter. Normally the grounding strap is obscured by vapors and is not visible. (Camera E17)

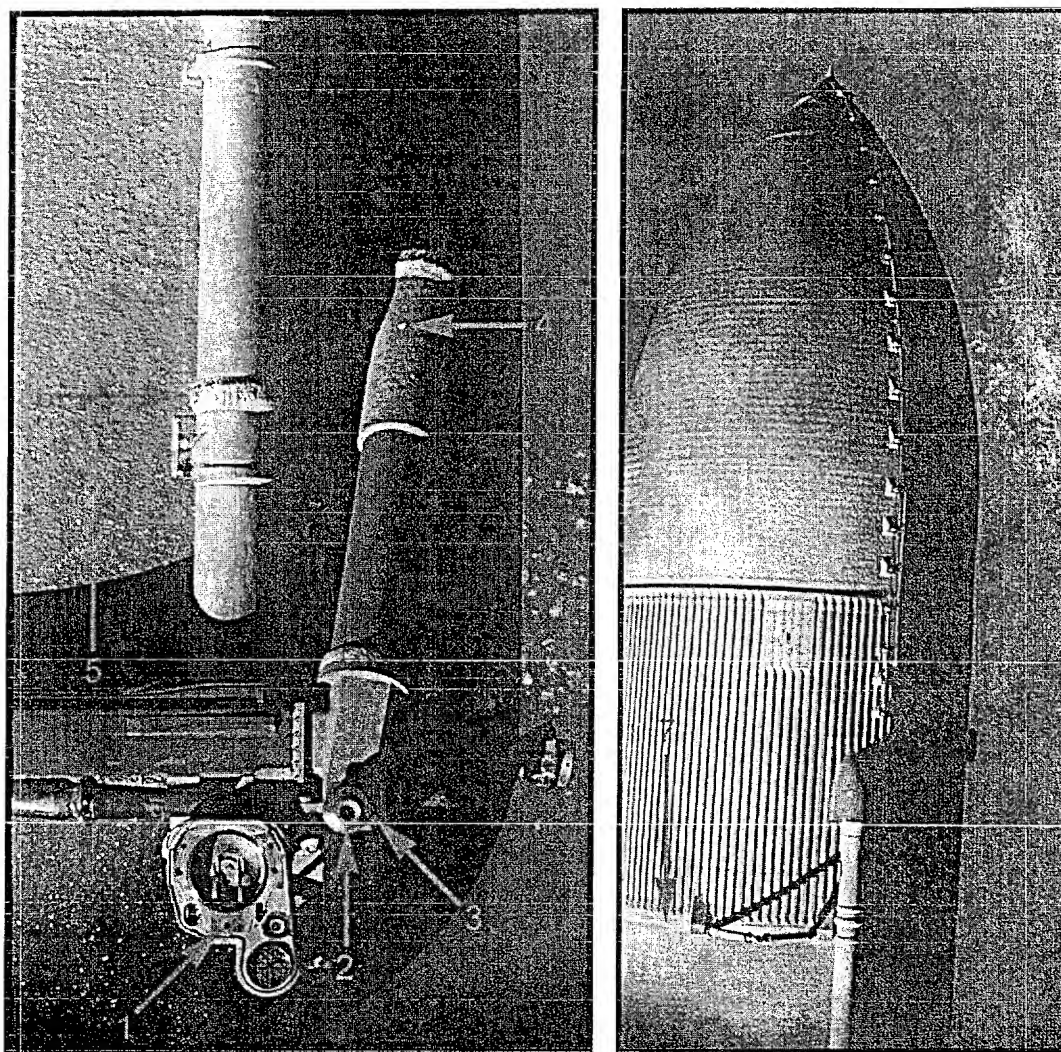
Figure 2.3.1 (A) 35mm Images of the ET during Separation (Frames 11 and 48)

The face of the LO2 umbilical carrier plate appeared to be in excellent condition (no indication of damaged or missing lightning contact strips was detected). See Figure 2.3.1 (A), annotation 1.

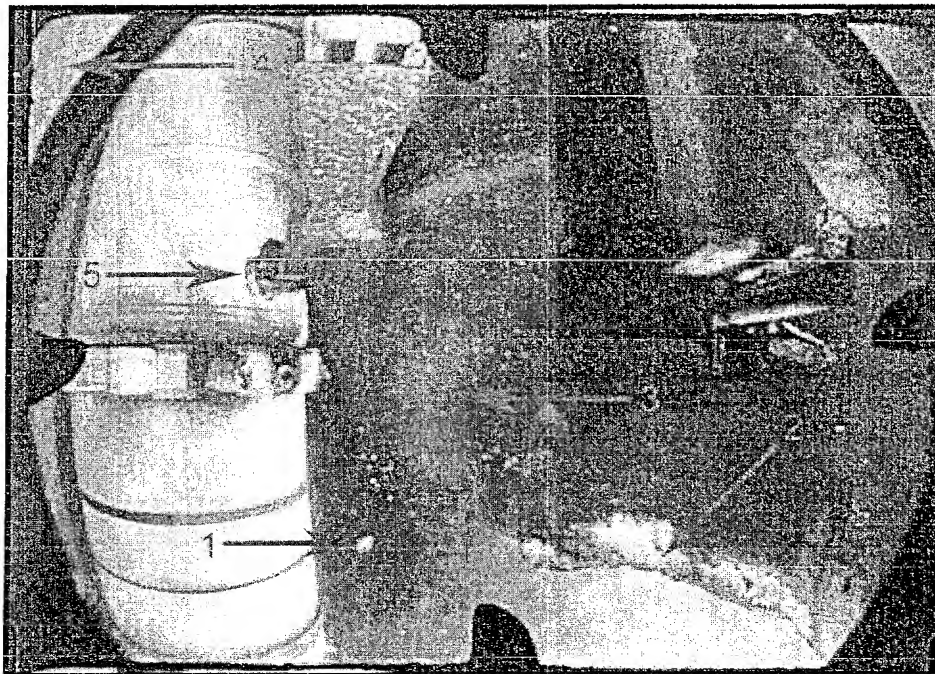
Figure 2.3.2 (A) 16mm Umbilical Well Camera SRB Separation Image

A slight rebound motion (twang) of the EB9 interface at the SRB / ET upper aft stabilization strut was visible during the LSRB separation. See Figure 2.3.2 (A), annotation 5. This motion was compared to the same umbilical well camera view from STS-109. An identical motion was also observed on the STS-109 film.

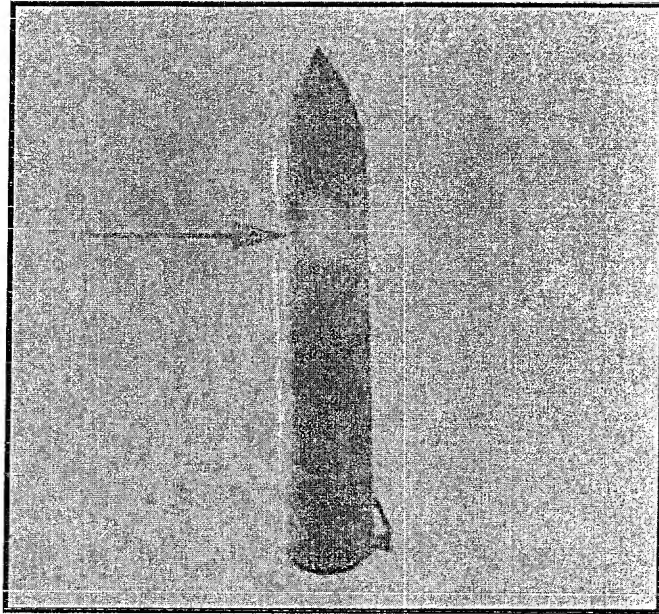
Figure 2.3.4 View of ET Venting After Separation

The astronauts acquired 8.3 minutes of handheld video of the ET on STS-111. Vapors coming from the ET intertank vent were noted. See Figure 2.3.4. Vapors coming from the ET intertank after separation have been seen on previous mission videos. No timing data was present on the video.

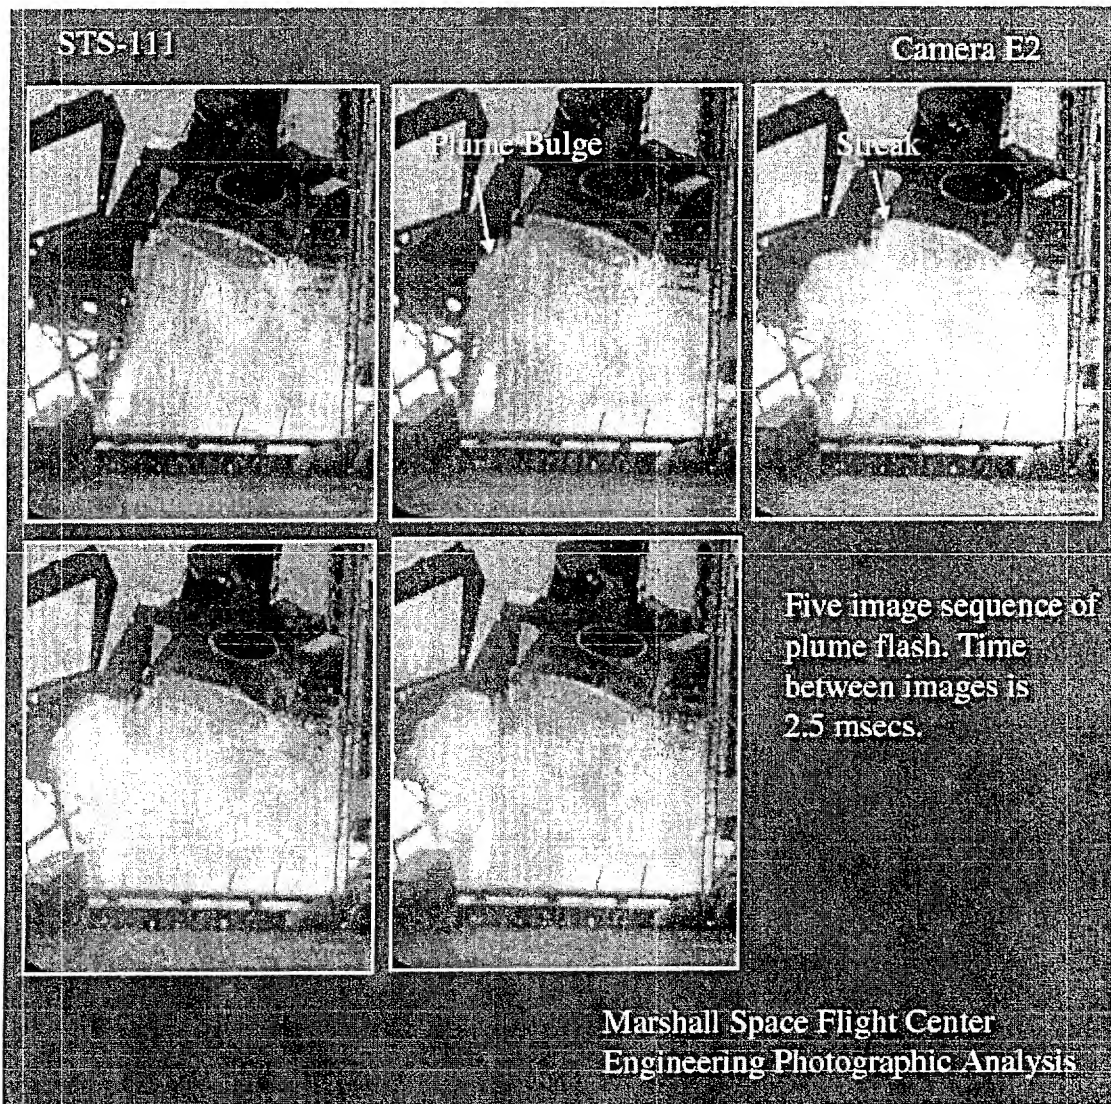
Film Camera E2: SSME#1 Plume Flash

Typically, reddish-orange free burning Hydrogen flashes are observed just after fuel lead during SSME ignition. This particular flash occurred as flow entrainment is being established and appears to initiate from a disturbance inside SSME #1 nozzle. A bulge in the plume, Figure 1, was observed in the frame just prior to the flash. Also, a band-like area of flow separation was noted as this event initiated, Figure 2.

SSME Project Office reported no concerns with this plume flash after reviewing available data.

Figure 1. E2: SSME#1 Plume Flash Sequence

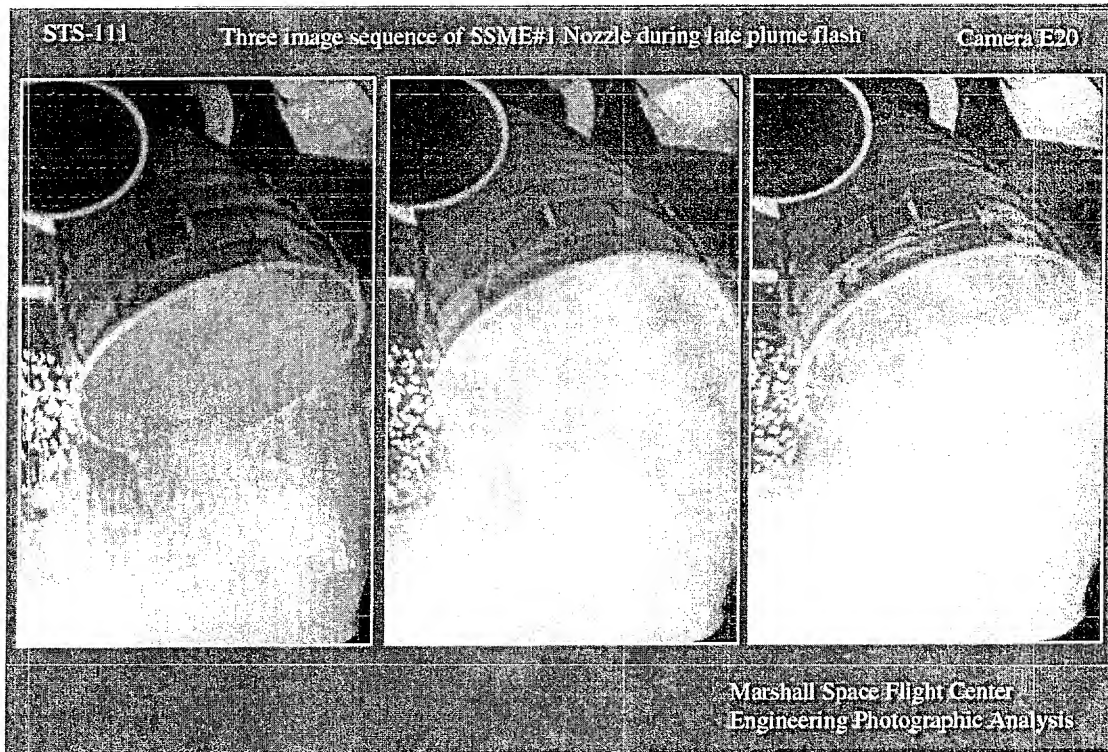
Film Camera E20: SSME#1 Plume Flash

Shown below are a sequence of images that illustrate the flow separation characteristics that initiate the plume flash event in SSME#1.

Figure 2. E20: SSME#1 Plume Flash Sequence

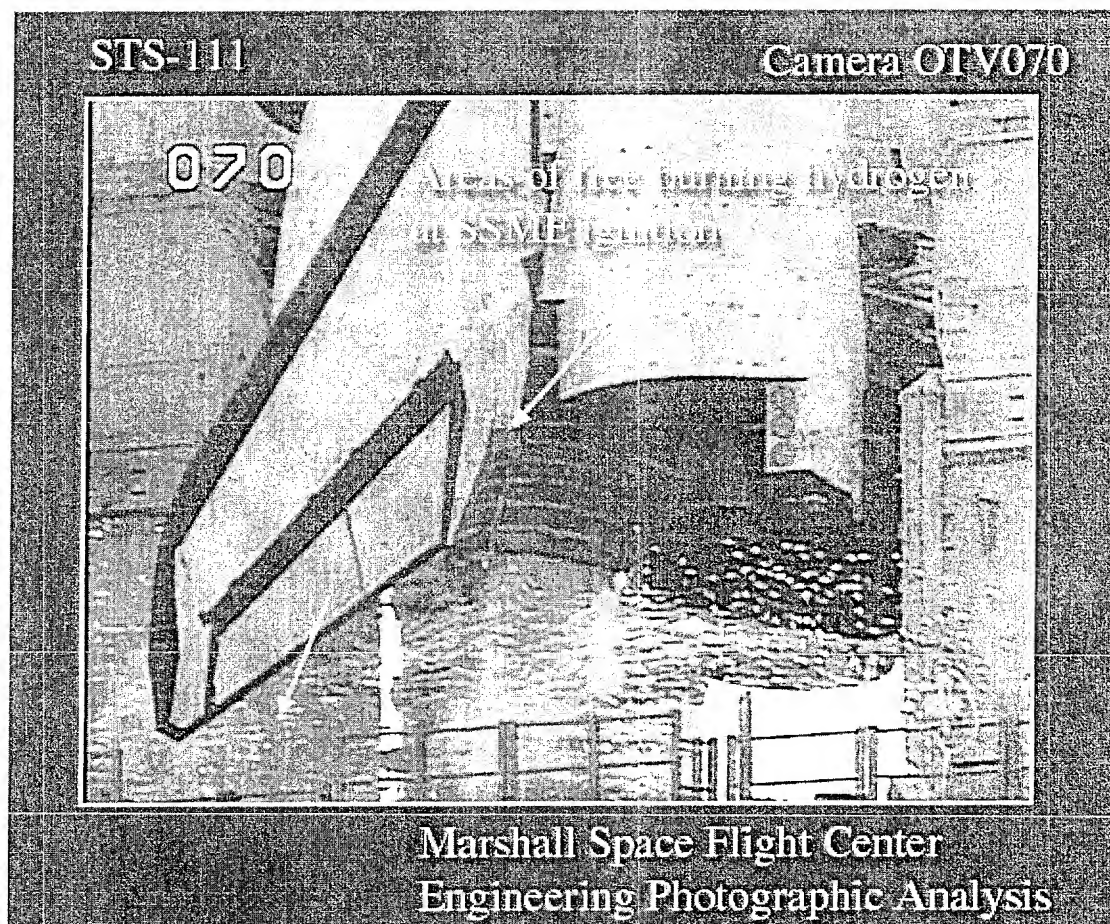
Video Camera OTV070: Free Burning Hydrogen

Free burning Hydrogen was observed in the vicinity of the drag chute door and vertical stabilizer. Free burning Hydrogen has previously been observed at SSME startup in these areas.

Figure 12. OTV070: Free Burning Hydrogen

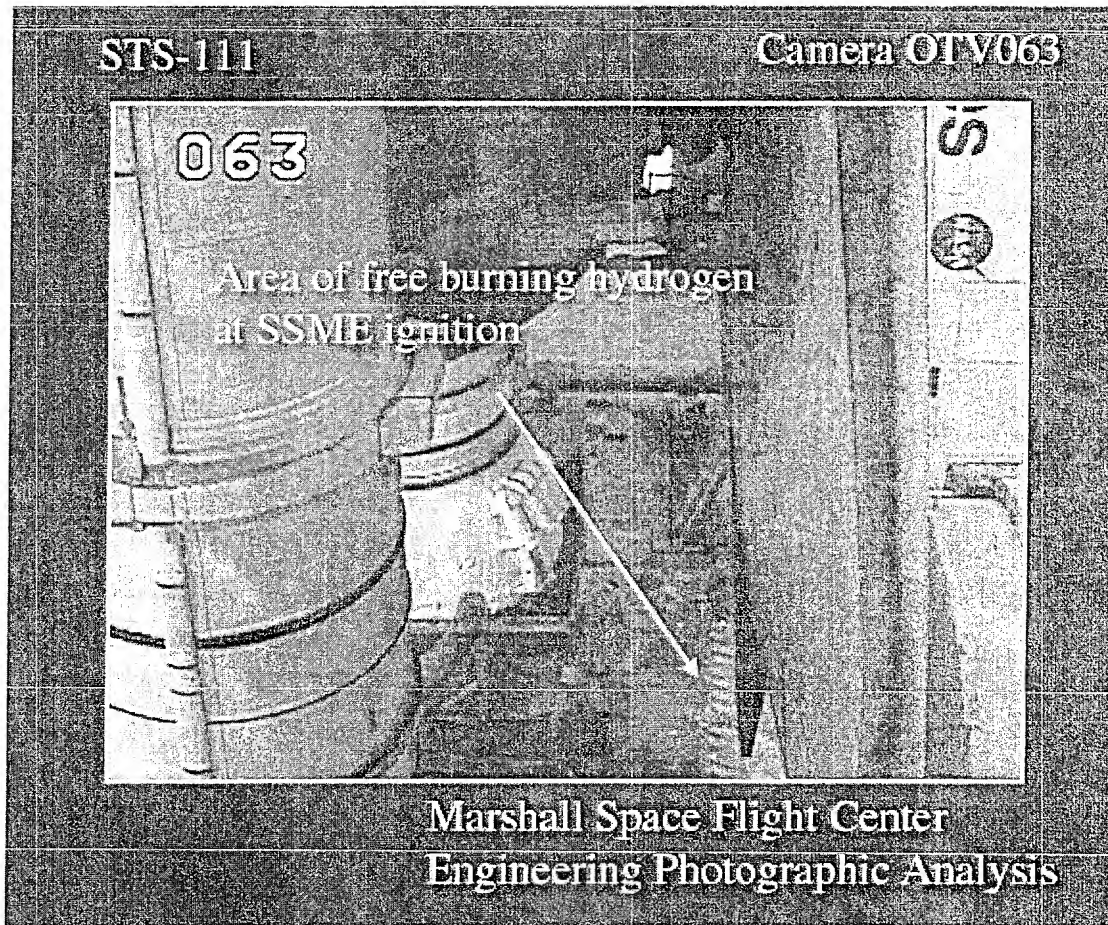
Video Camera OTV063: Free Burning Hydrogen

Free burning Hydrogen was observed on the -Z side of the body flap at SSME startup. Free burning Hydrogen has been observed on the -Z side of the body flap on previous missions.

Figure 13. OTV063: Free Burning Hydrogen

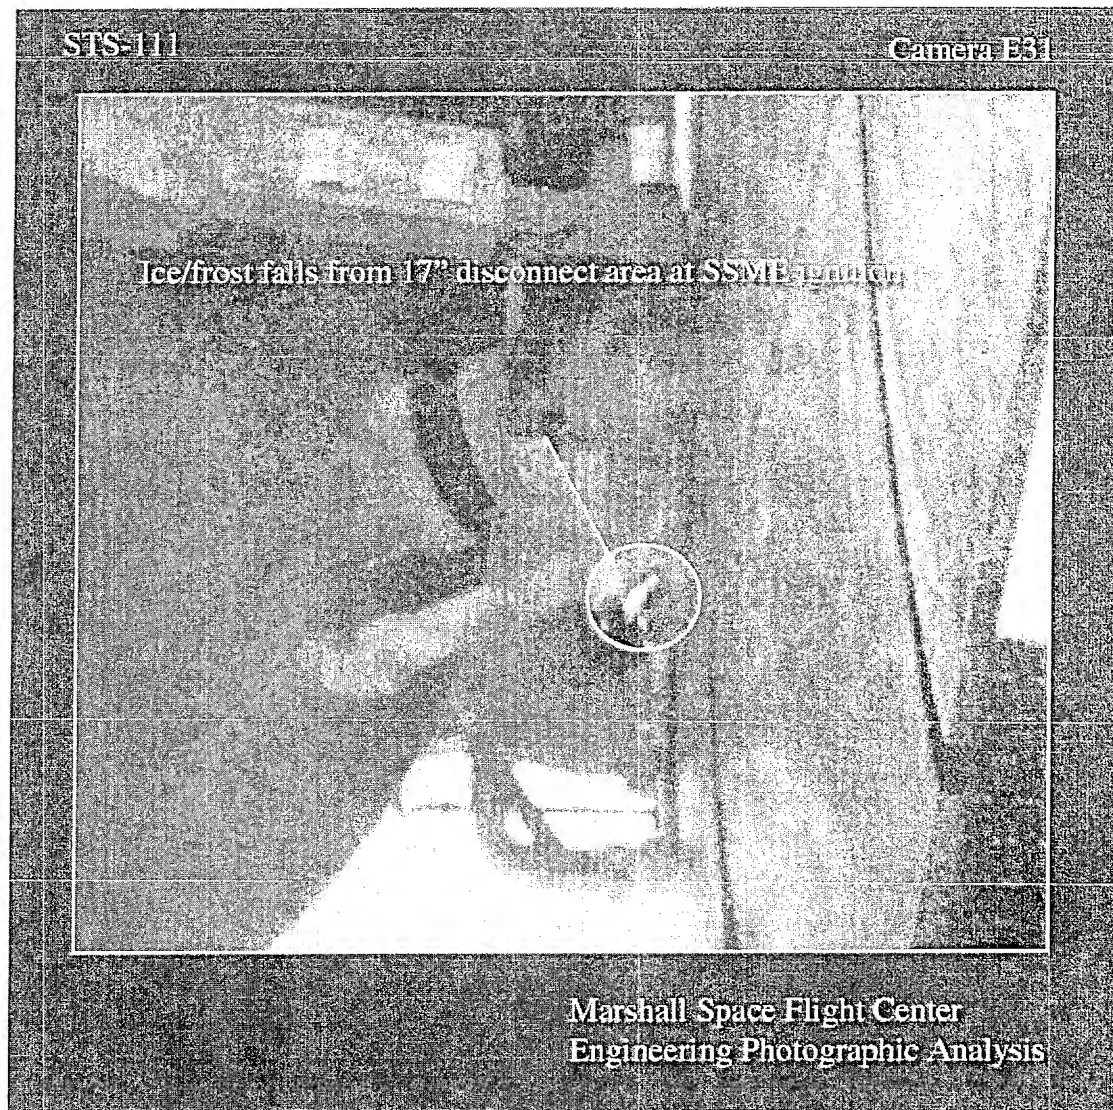
Film Camera E31: Ice/Frost Falls from 17-inch Disconnect

Typical ice/frost was observed falling from the 17-inch disconnects.

Figure 15. E31: Ice/Frost Falls from 17-inch Disconnect

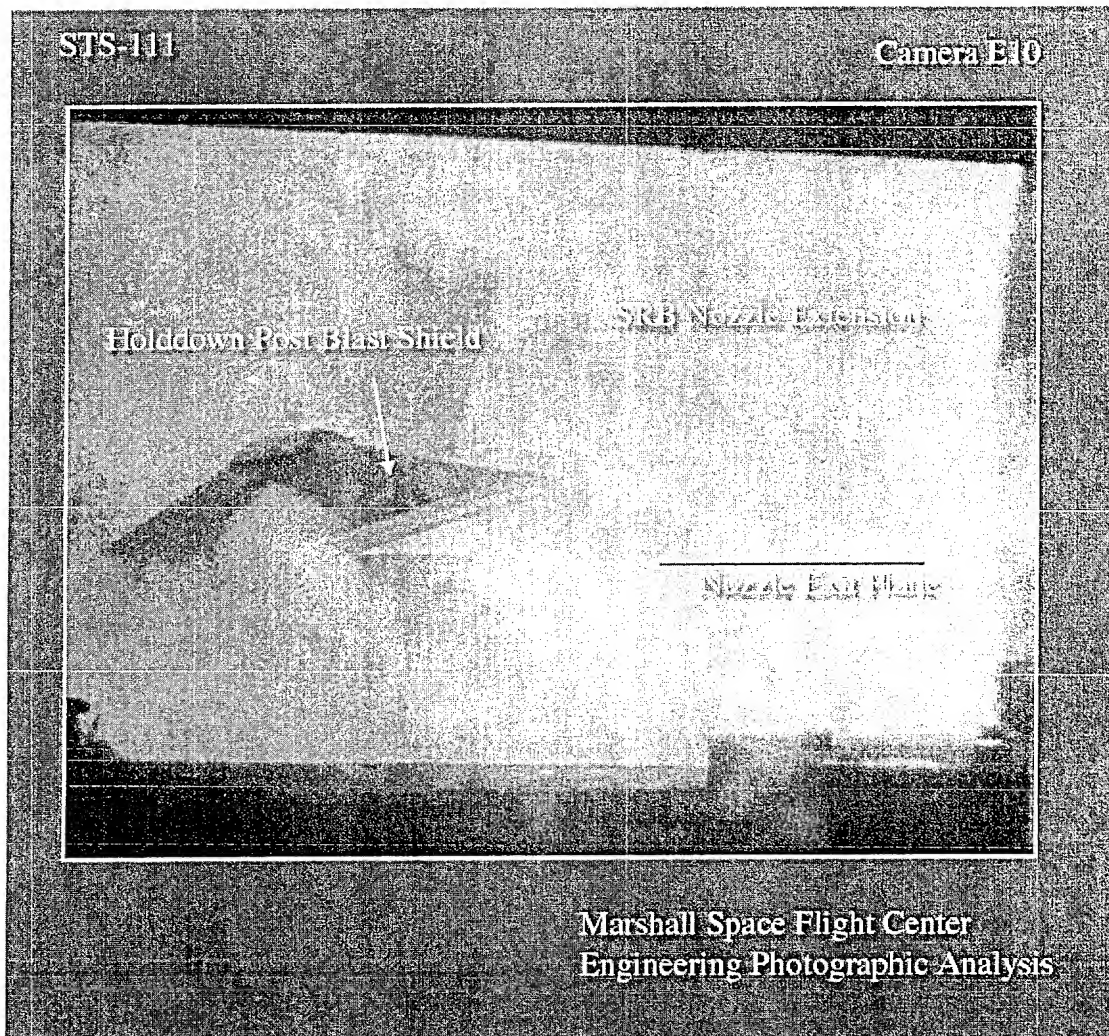
A review of film from camera E10 for the last mission utilizing MLP-1, STS-108, also revealed a similar phenomenon.

Figure 18. E10: Blast Deflection Shield Descent

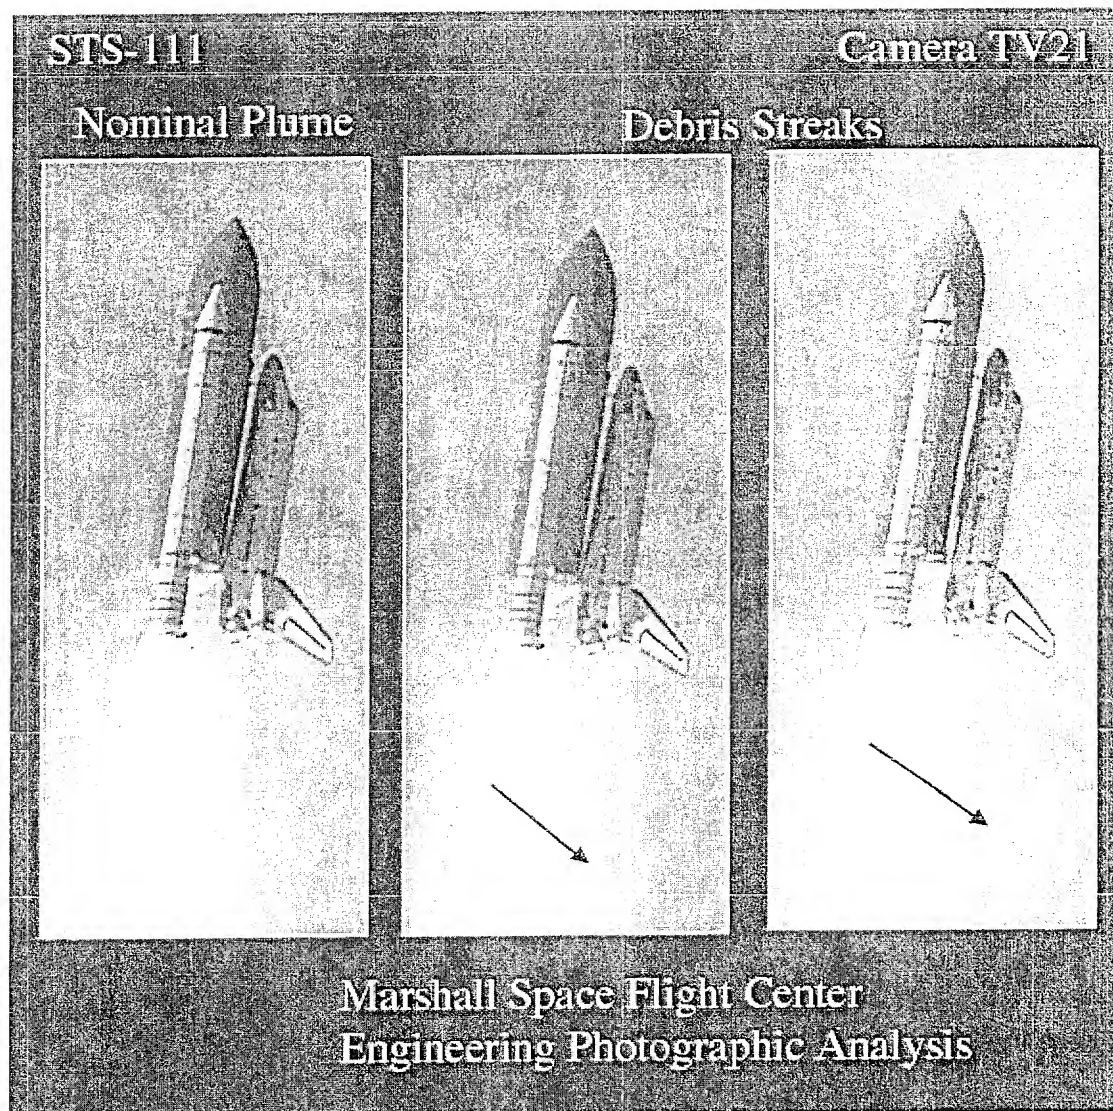
Video Camera TV21: Debris-induced Streaks in SSME Plumes

Debris-induced streaks were observed in SSME plumes during ascent.

Figure 20. TV21: Debris-induced Streaks in SSME Plumes

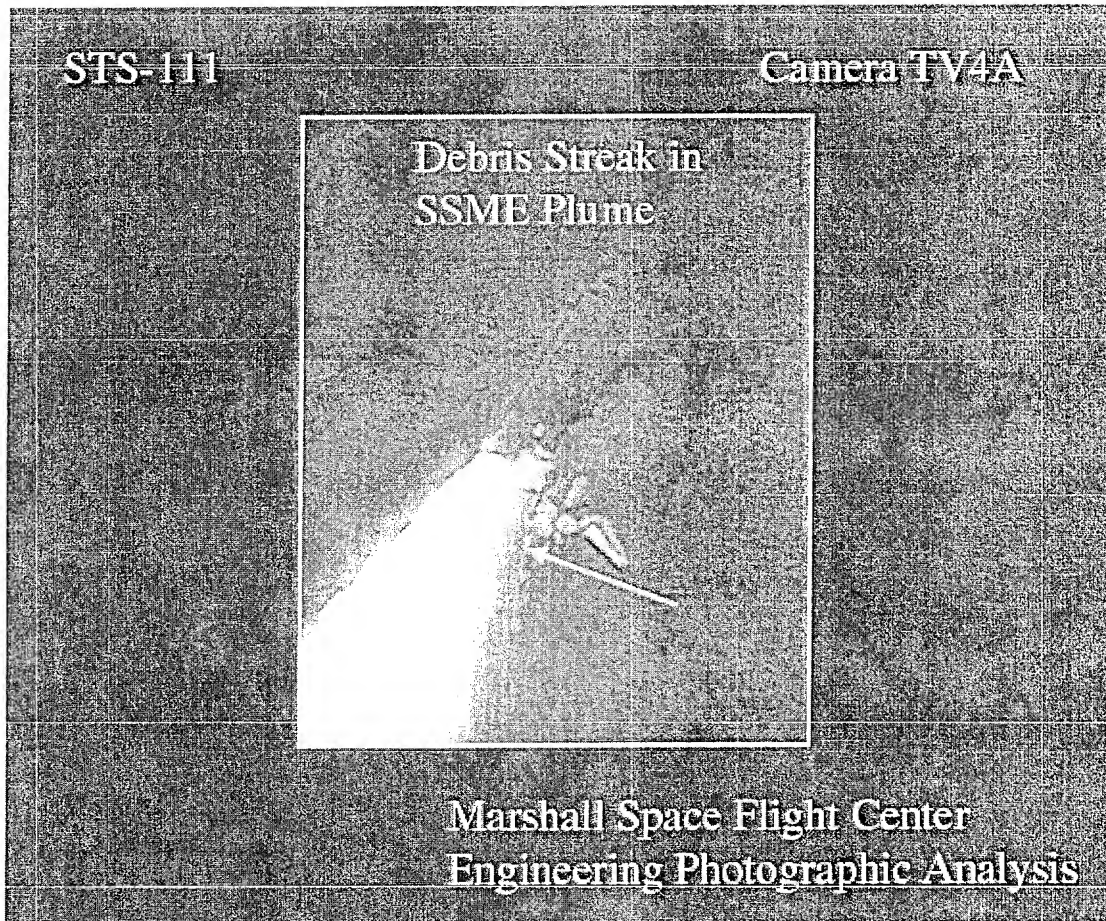
Figure 21. TV4A: Debris-induced Streaks in SSME Plumes

Video Camera TV4A: Debris-induced Streaks in SSME Plumes

Debris-induced streaks were observed in SSME plumes during ascent.

TV13	Linear optical distortions noted. Camera occasionally loses focus.
TV4A	Debris-induced streak observed in SSME plume. SRB separation: 156:21:24:52.9 UTC. Red-colored flash noted near SSME plumes prior to liftoff. Condensation vapors noted surrounding vehicle during ascent. Light colored debris ejected from SRB plumes during ascent at 156:21:23:59.595, 156:21:24:00.929, and 156:21:24:04.967 UTC. Dark puffs in SRB plumes noted at 156:21:24:42.271, 156:21:24:42.504, and 156:21:24:42.638 UTC.
TV7A	Red-colored flash noted near SSME plumes prior to liftoff.
ET204	Atmospheric haze degrades image quality.
ET207	Glowing debris particles ejected from SRB plume prior to, during and after separation. Linear optical distortions noted. Flow recirculation noted. Body flap motion noted. Condensation cloud surrounding vehicle noted. OMS Assist burn noted after SRB separation. Ice on SSME3 nozzle appears normal.

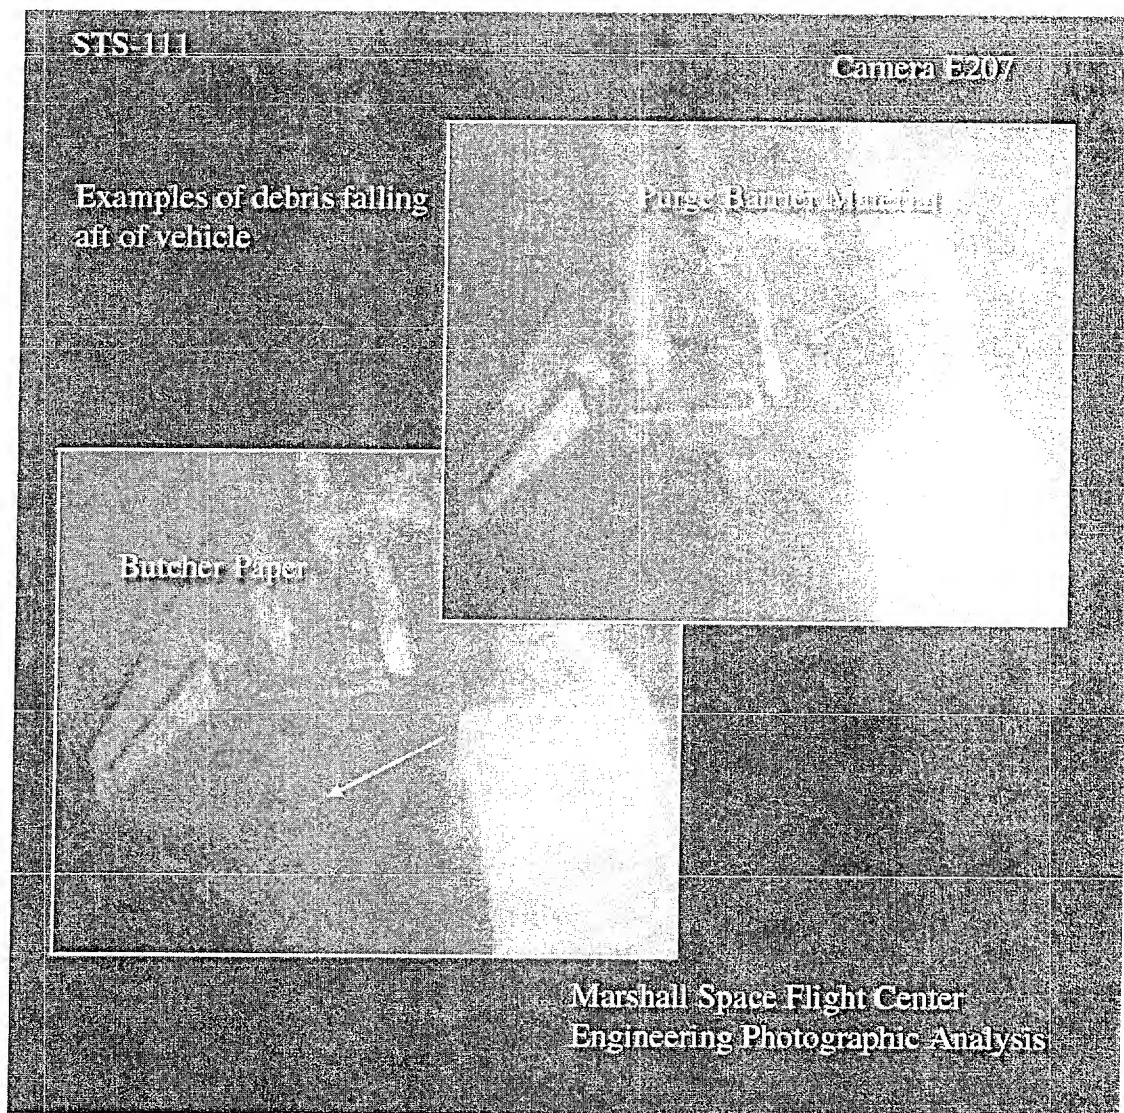
Figure 23. E207: Examples of Debris Falling Aft

Film Camera E207: Examples of Debris Falling Aft

Typical sources of debris falling aft of the vehicle during ascent are Purge Barrier Material and Butcher Paper.

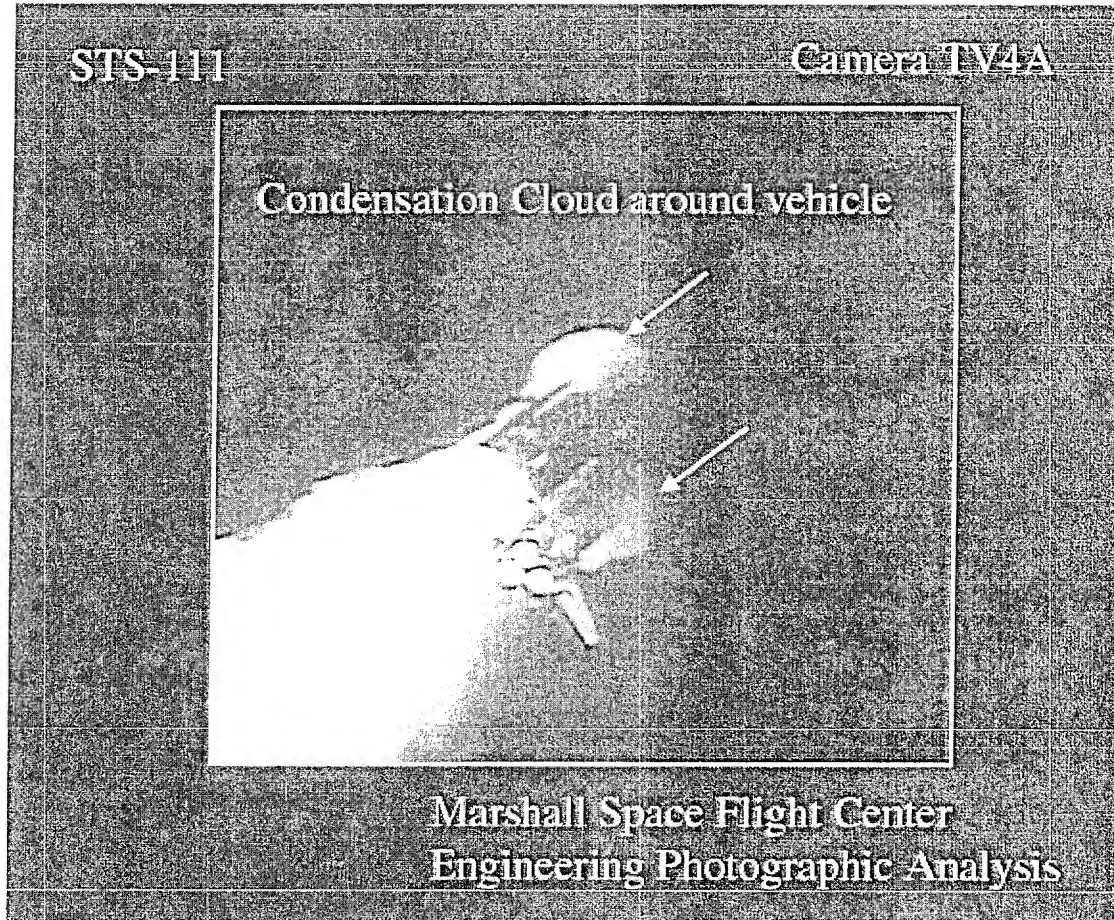
Figure 24. TV4A: Condensation Cloud

Video Camera TV4A: Condensation Cloud

A condensation cloud was observed around the vehicle during ascent.

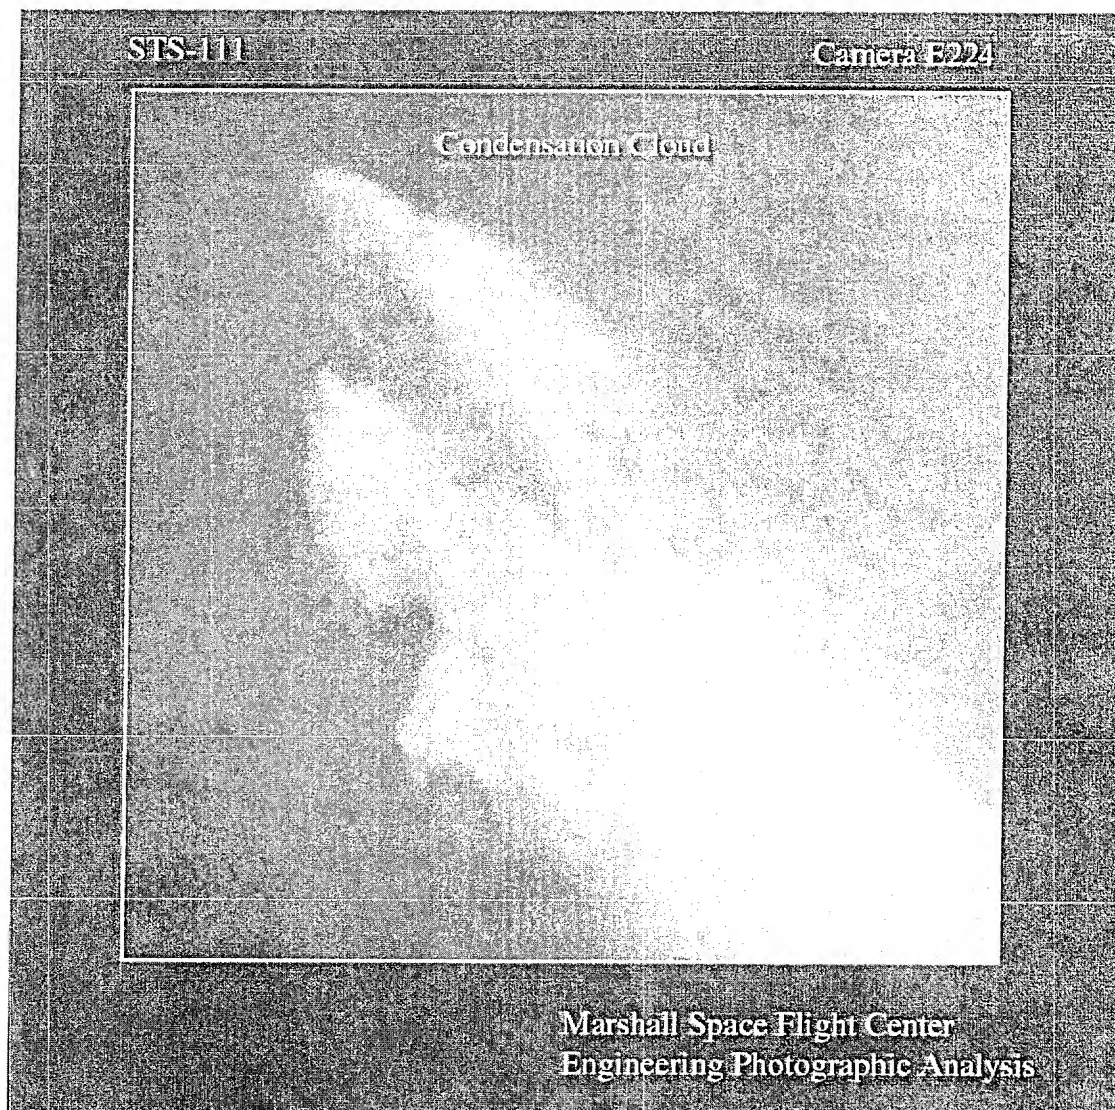
Figure 25. E224: Condensation Cloud

Film Camera E224: Condensation Cloud

A condensation cloud was observed around the vehicle during ascent.

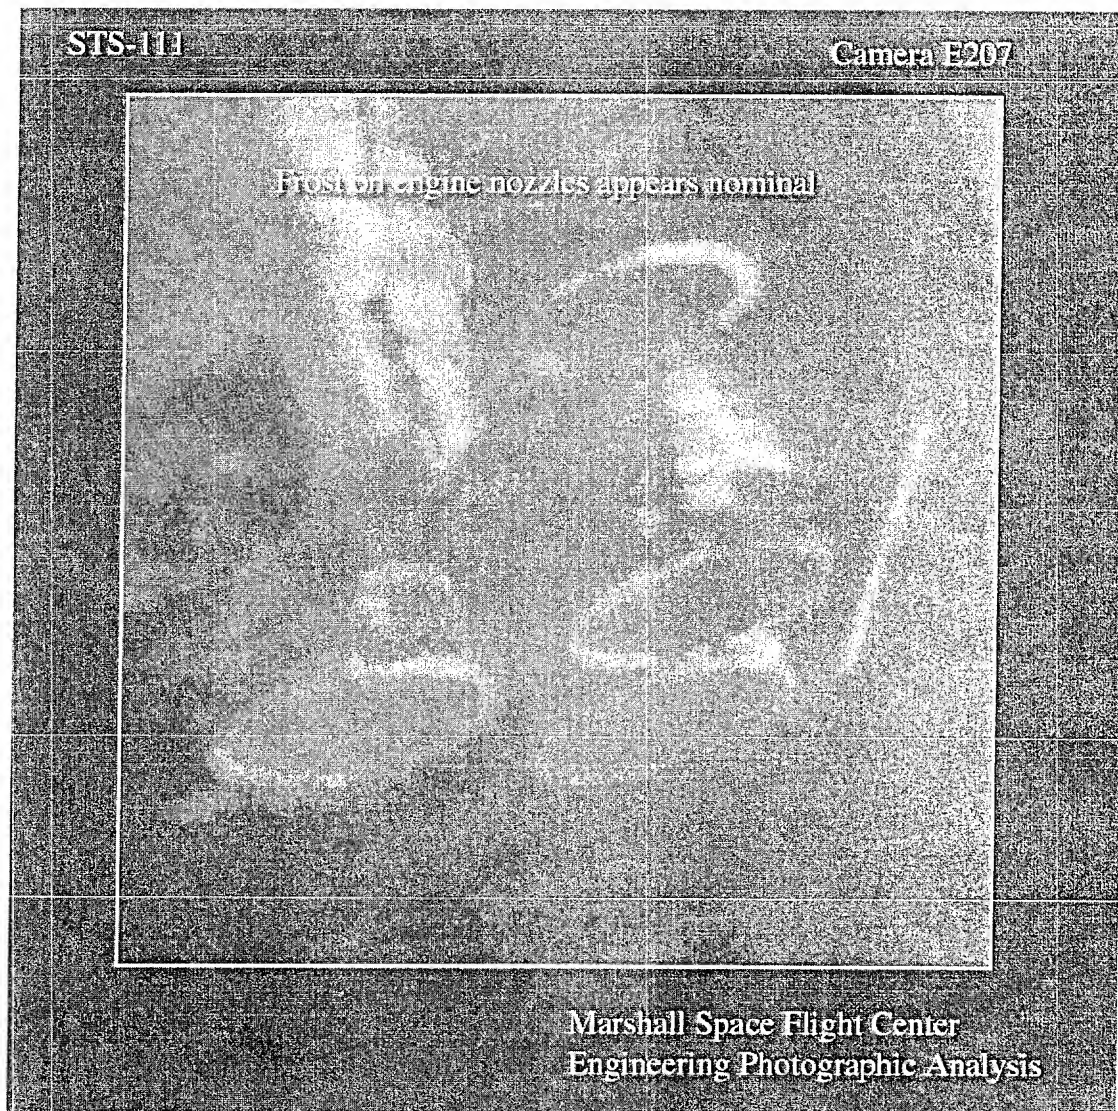
Figure 26. E207: Nominal Frost on SSME Nozzles

Film Camera E207: Nominal Frost on SSME Nozzles

Frost on SSME nozzles appears nominal.

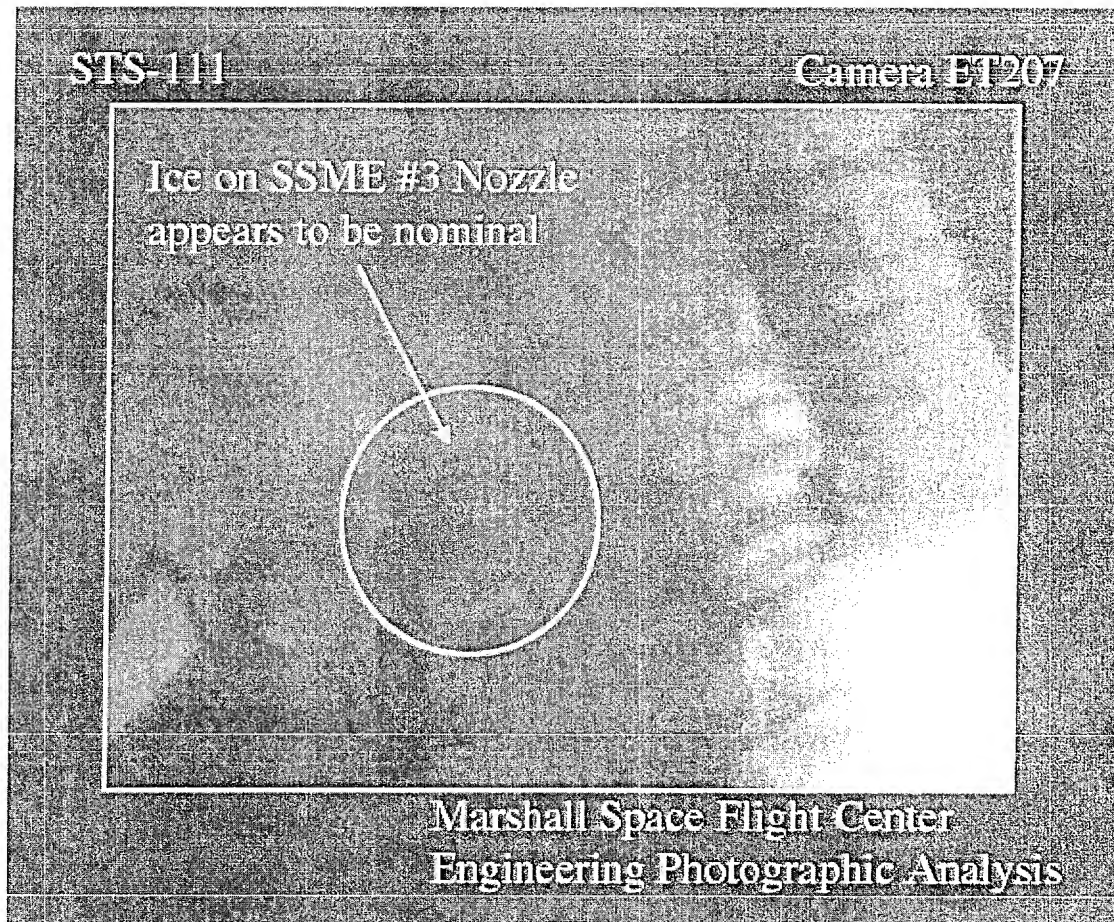
Figure 27. ET207: Nominal Frost on SSME#3 Nozzle

Video Camera ET207: Nominal Frost on SSME#3 Nozzle

Frost on SSME#3 nozzle appears nominal.
